Rebuilding My Observatory

Steve Harris

Rebuild of the Mk.2 Observatory

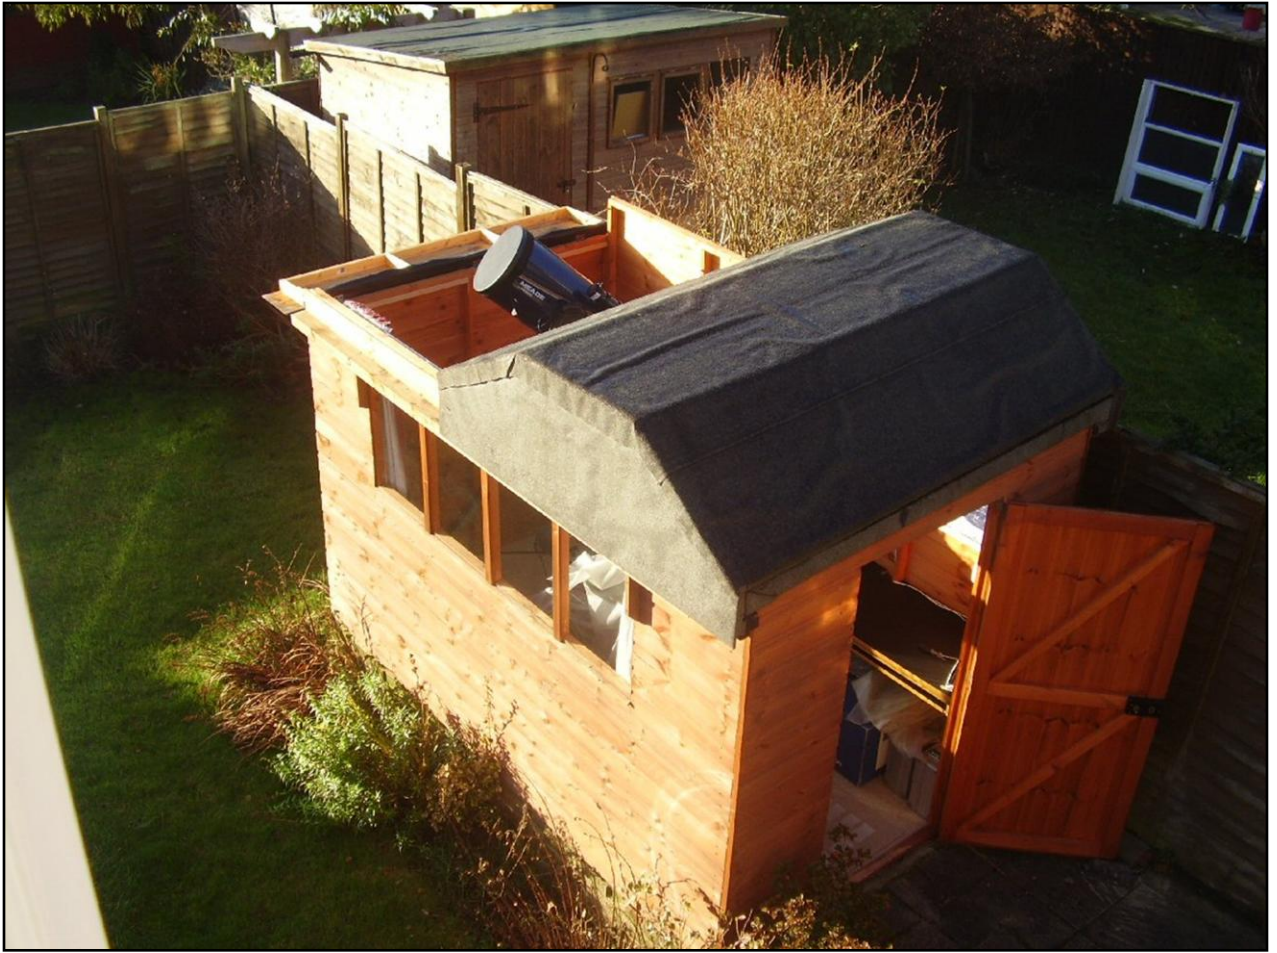
The roof of the wooden shed was supplied with the roof in two sections so I decided to modify it so that one half of the roof could slide back over the other half.

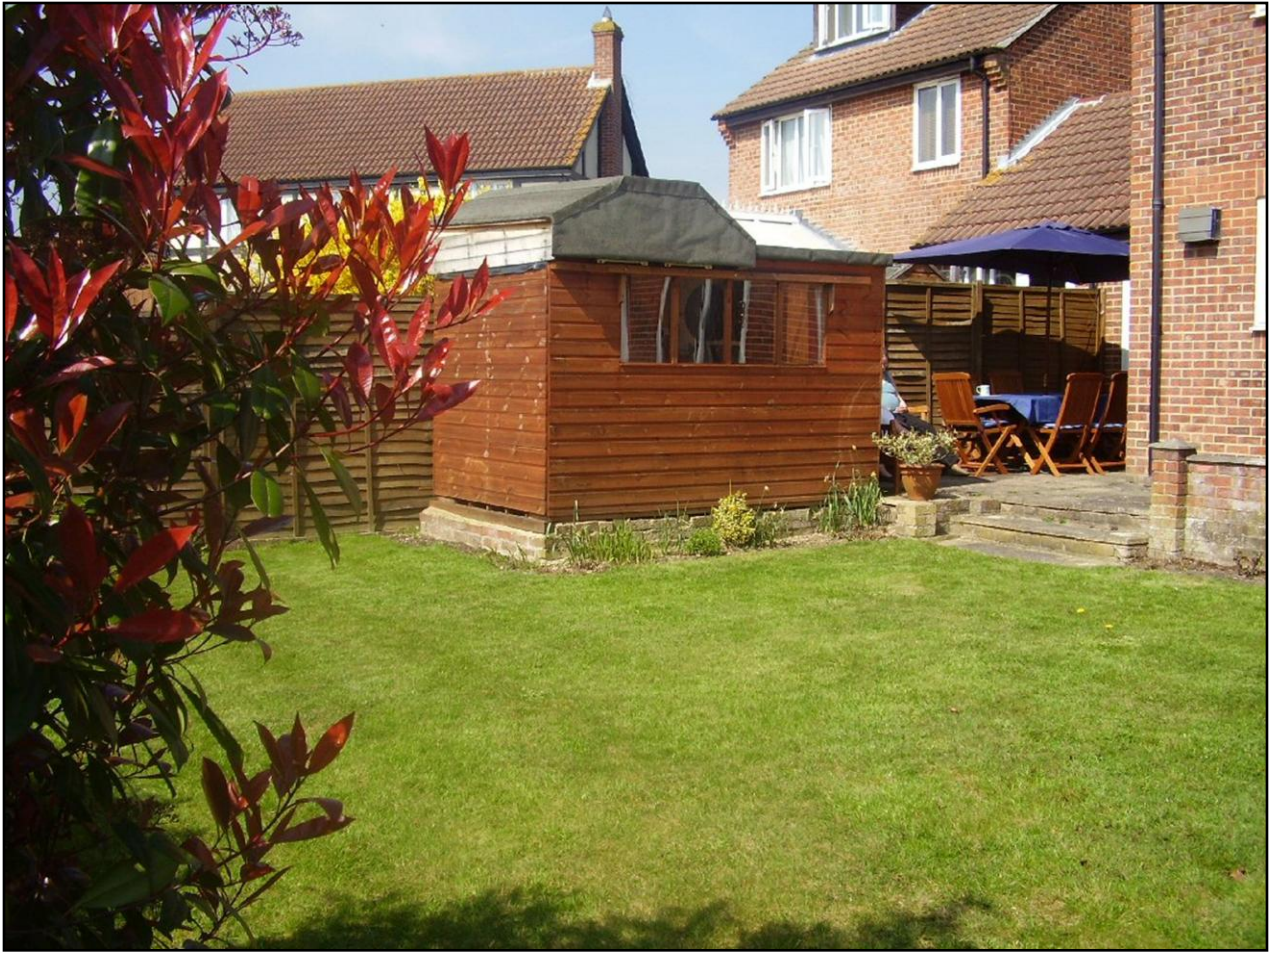
I ended up building a completely new roof half and stowed the original half behind the shed. The special roof was raised to allow the telescope to be rotated and elevated inside the closed roof.

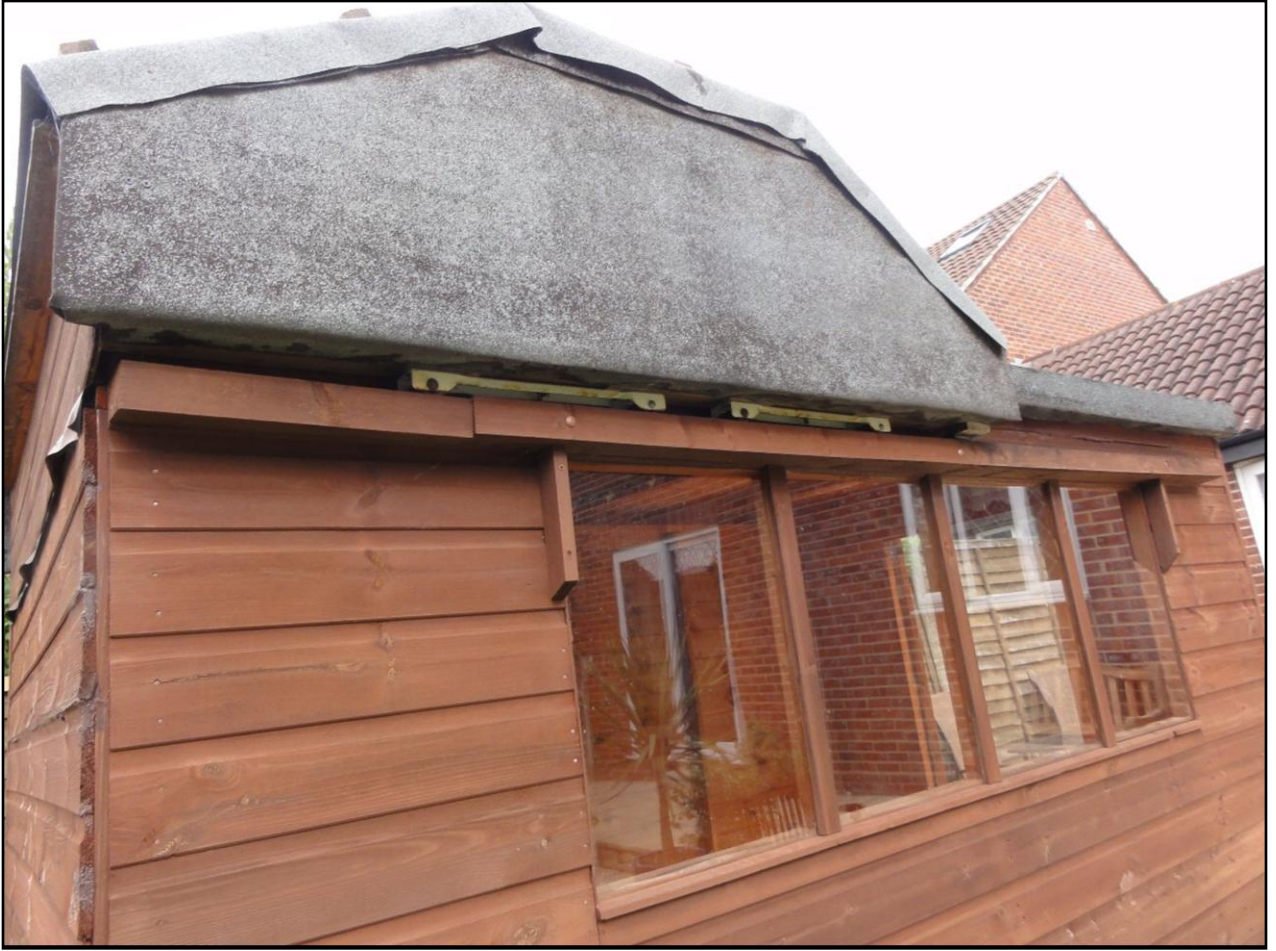
The original roll off raised roof was to be replaced with the original flat half of the roof. It would have to be raise to allow it to be rolled back over the fixed half of the roof. The original wheeled trolleys would be used.

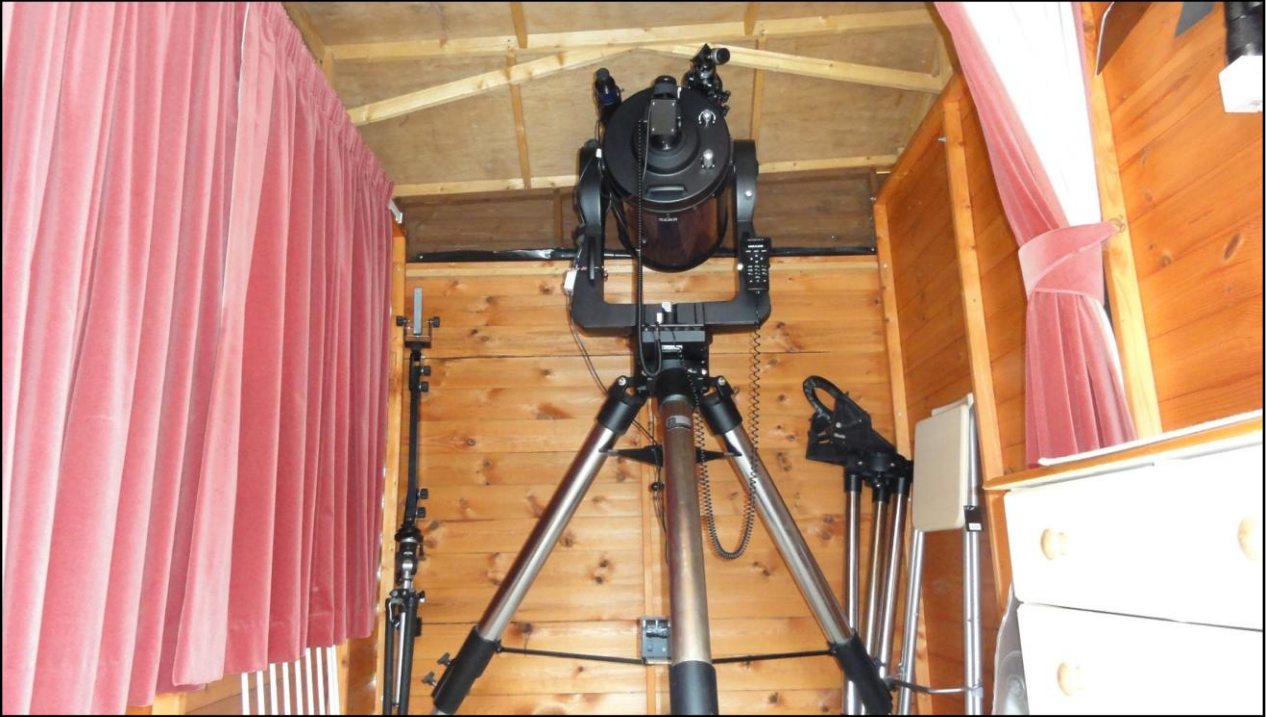
The Meade LX200 on its tripod

Peggy was supplied with a giant field tripod that I decided to replace with a fixed pier and equatorial wedge.

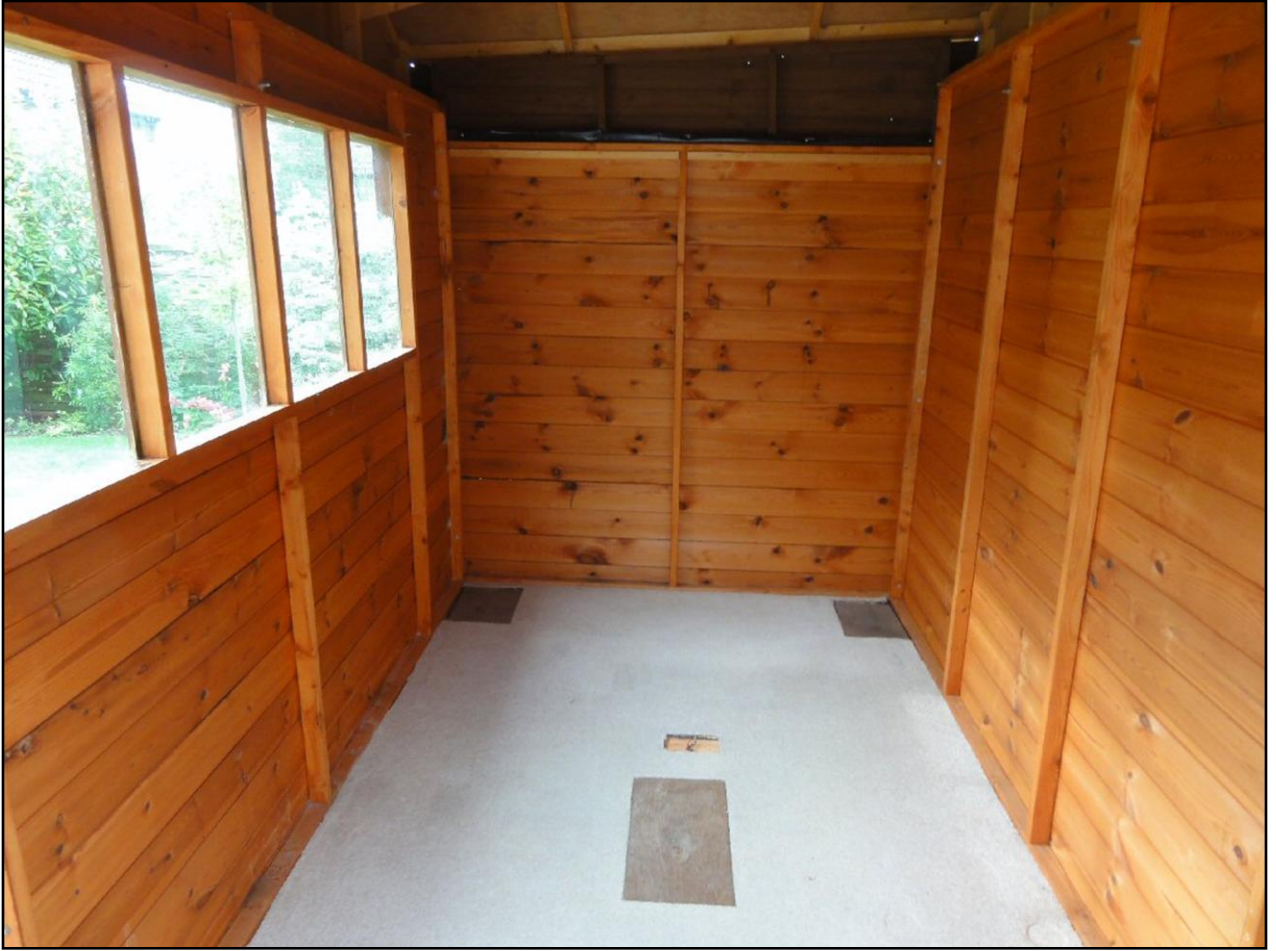
The first step for the rebuild was to empty out the observatory. This view shows the brick pads that the tripod legs stood on. The brick pads were set into the foundation of the observatory to stop movement on the wooden floor causing vibrations on the telescope.

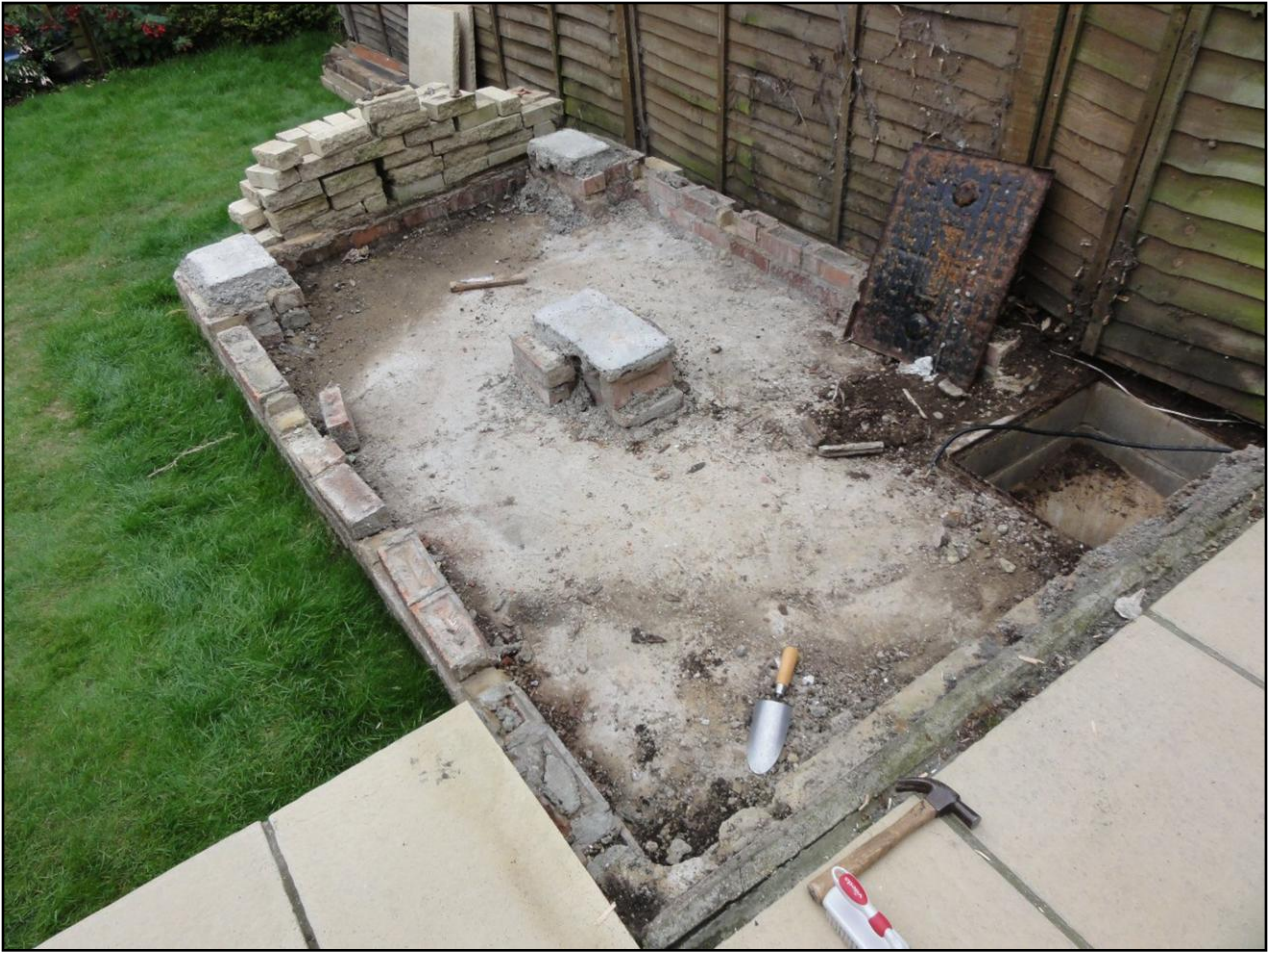
With the wooden shed removed the old foundations were revealed. The drain that was hidden under the shed was for the rain water drain pipe from the garage. The brick foundation wall was to be removed along with the tripod footing pads. The new white brick foundation was waiting behind the shed to be laid to match the new patio.

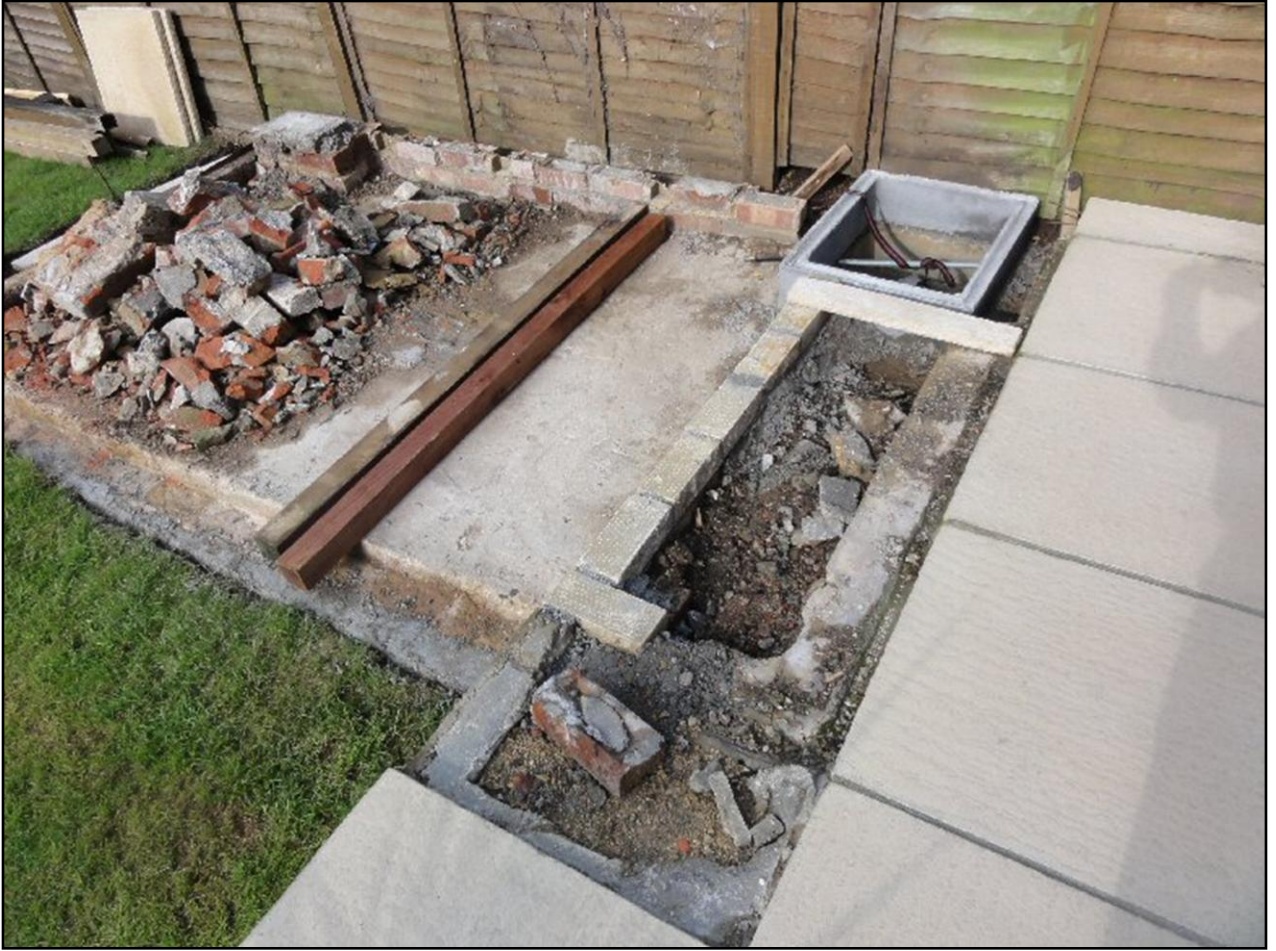
The drain level had to be raised to the height of the new patio and the patio wall extended to the drain. The east and west brick foundation wall was dismantled (with a lot of work and a sledge hammer). The rubble from the wall was used as ballast with the concrete for the new pier foundation.

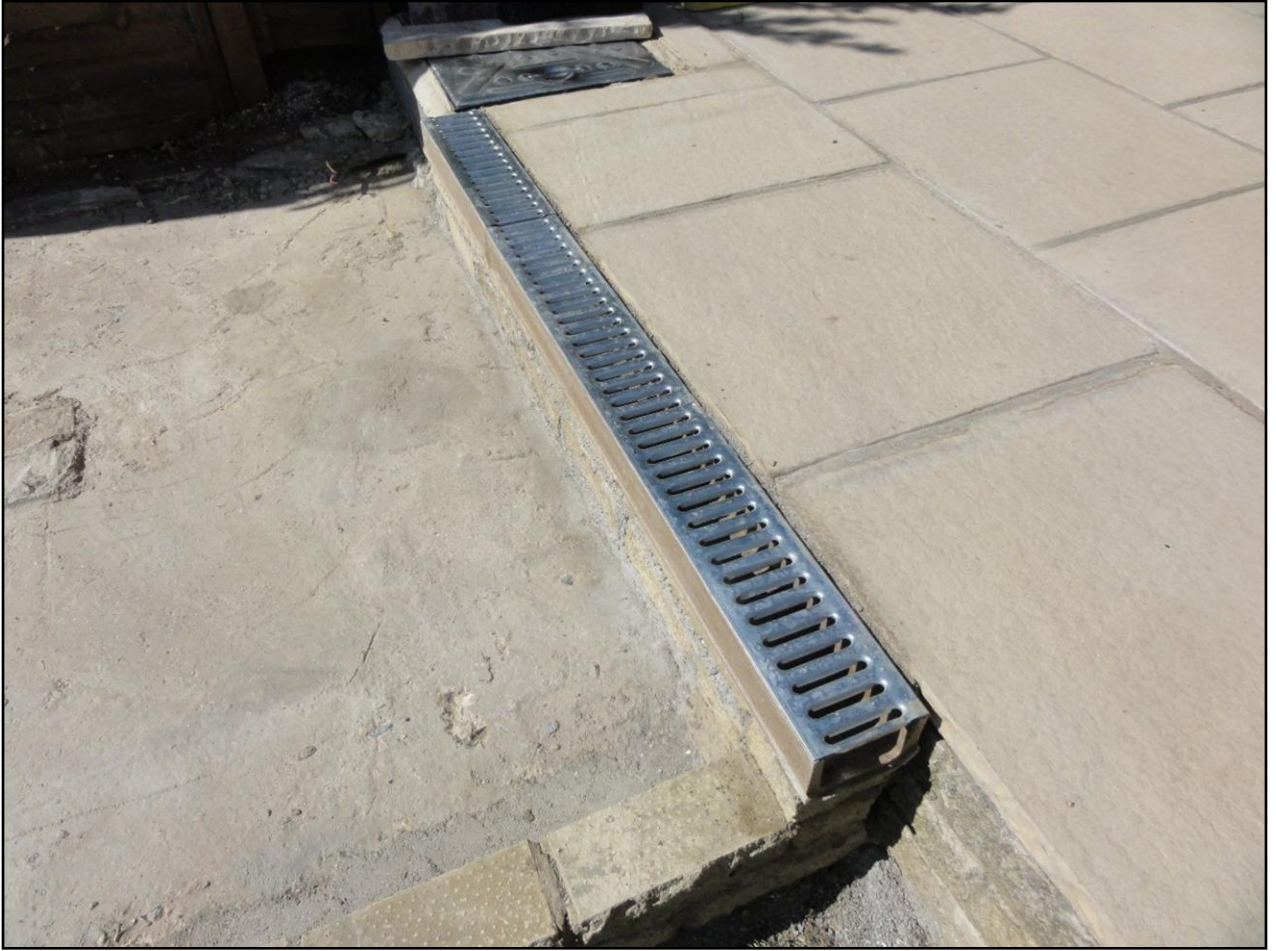
The paving slabs were laid to complete the new patio up to the new 'raised' drain. A drain was fitted between the patio and the observatory foundations to divert rain water off the patio.

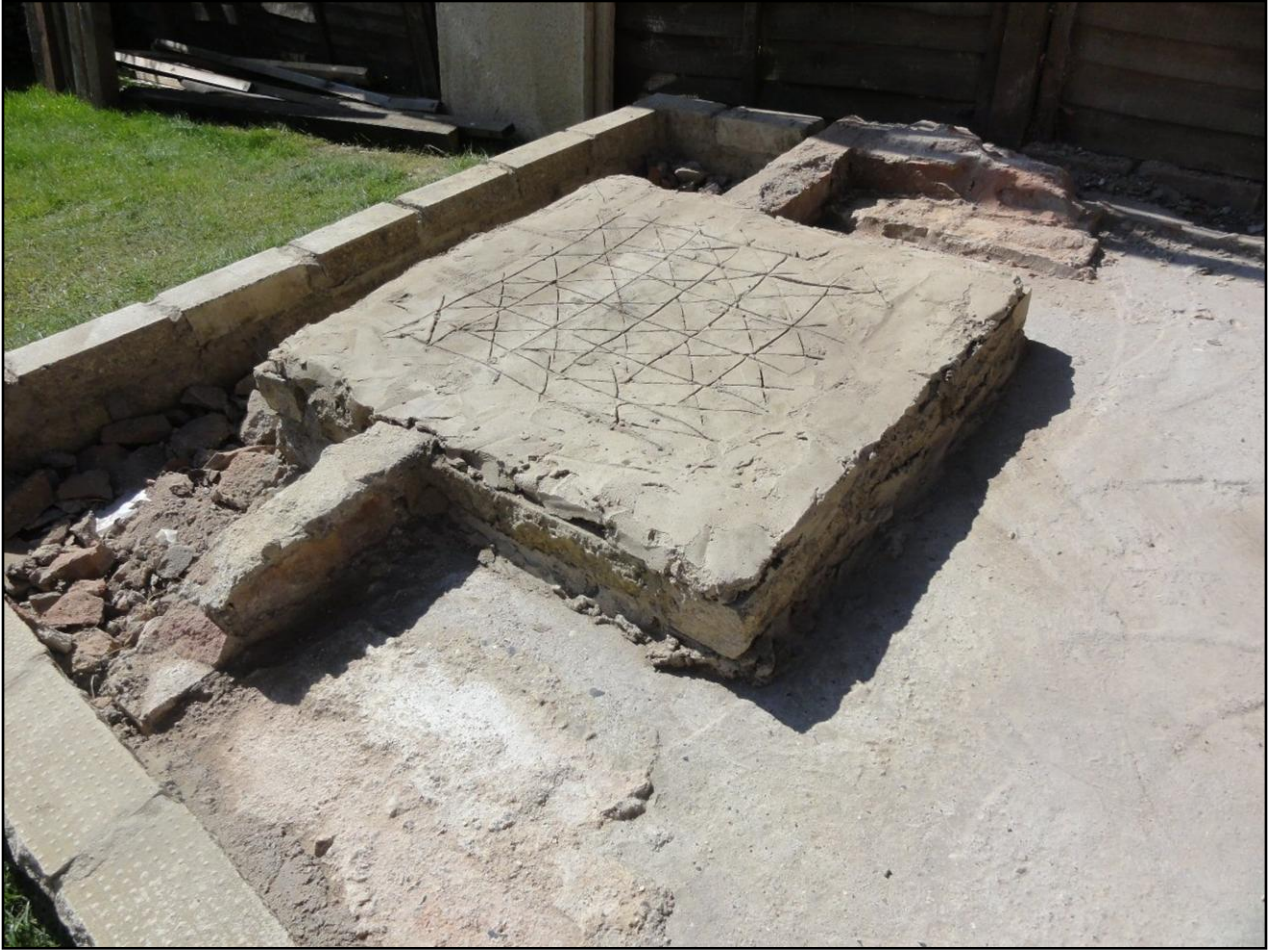
I decided to leave the old rear foundation wall and incorporate it into the pier base. A large hole was dug for the concrete and rubble pier base and the back foundation brick wall was built.

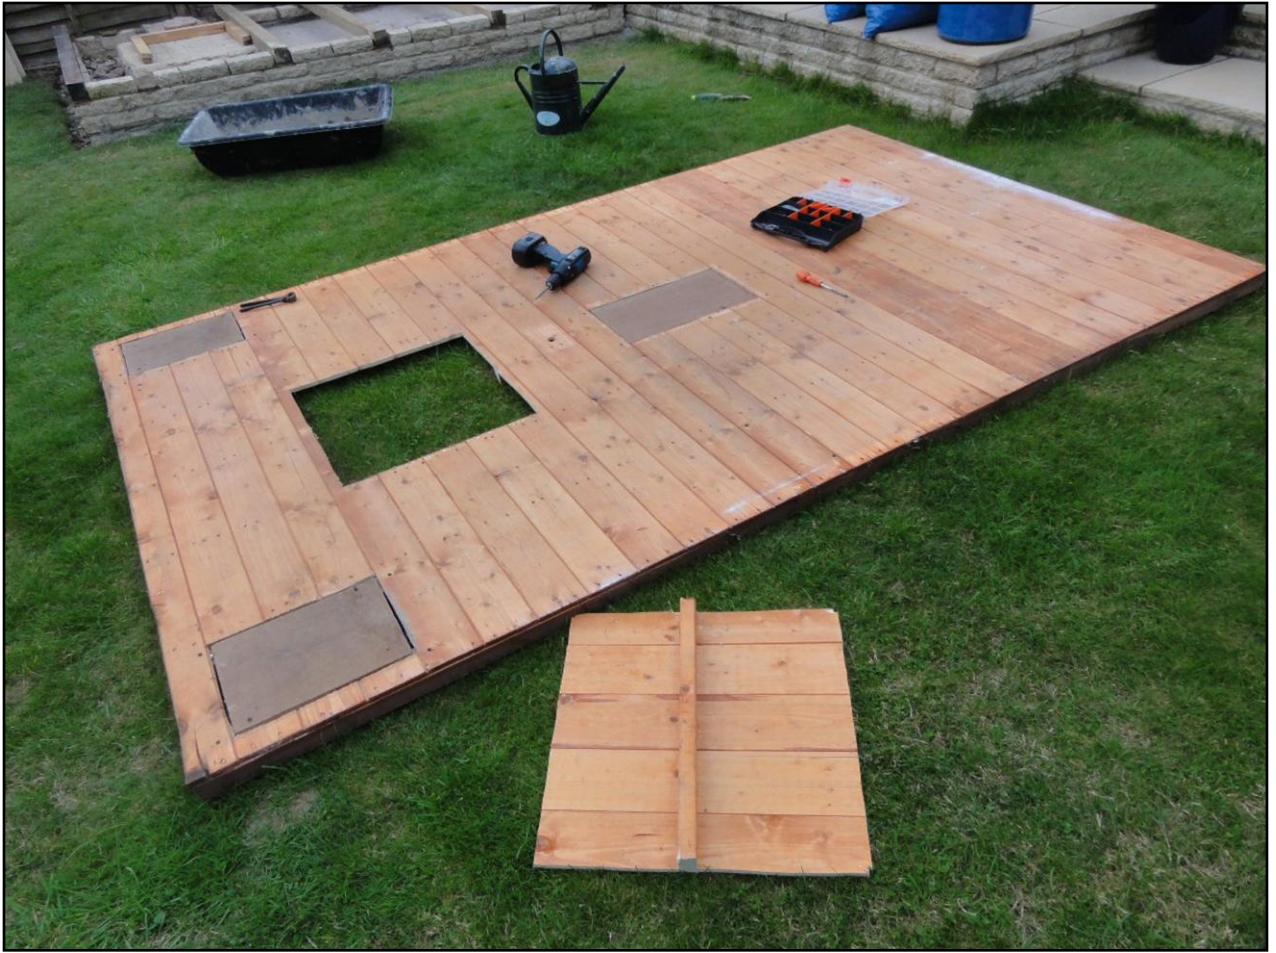
The wooden floor was temporarily fitted to ensure that the concrete pier base correctly aligned with the new hole in the floor. The old tripod pad holes were repaired.

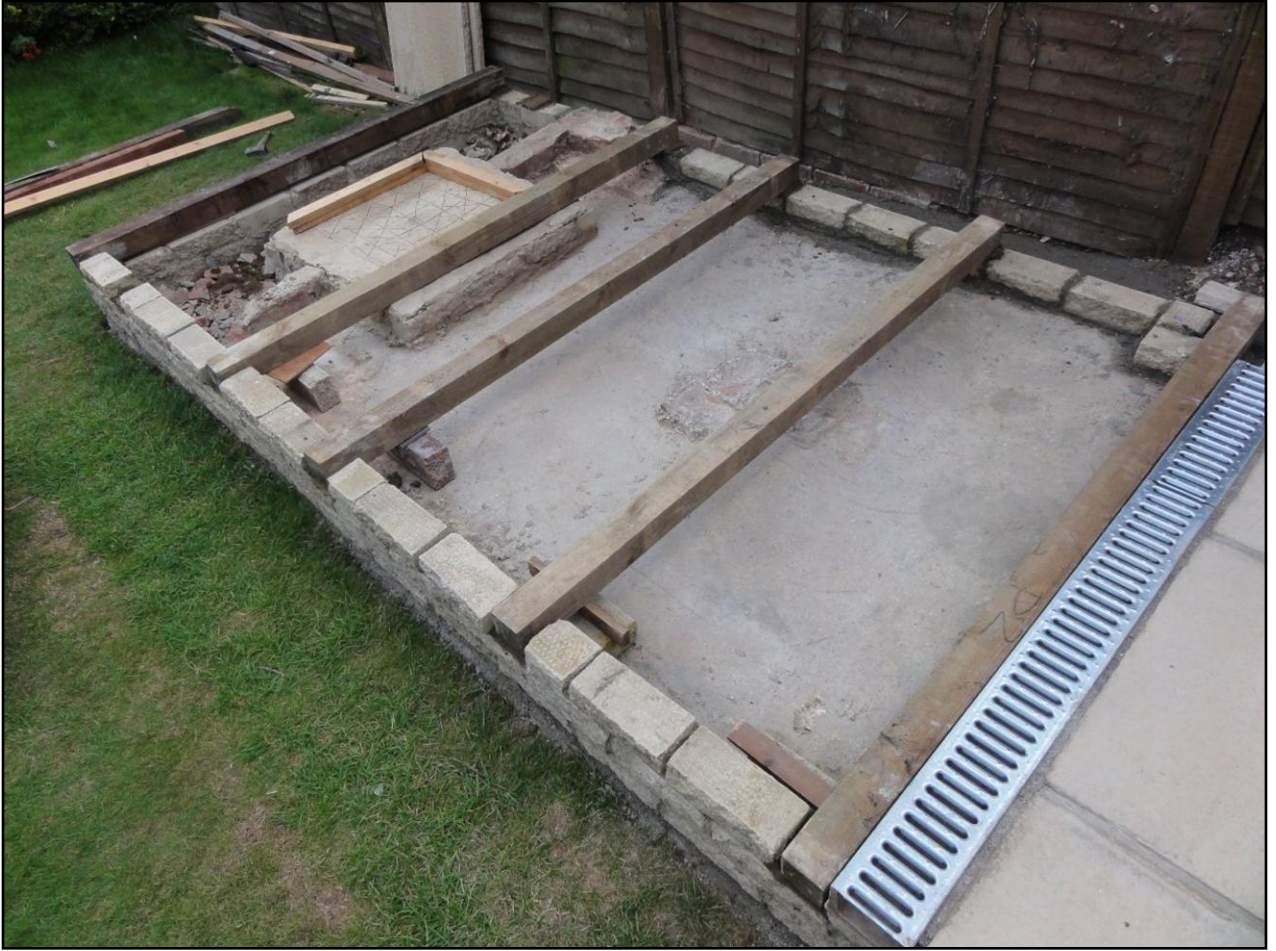
Wood shuttering was installed for casting the concrete base for the pier. The floor supporting beams were fitted and levelled.

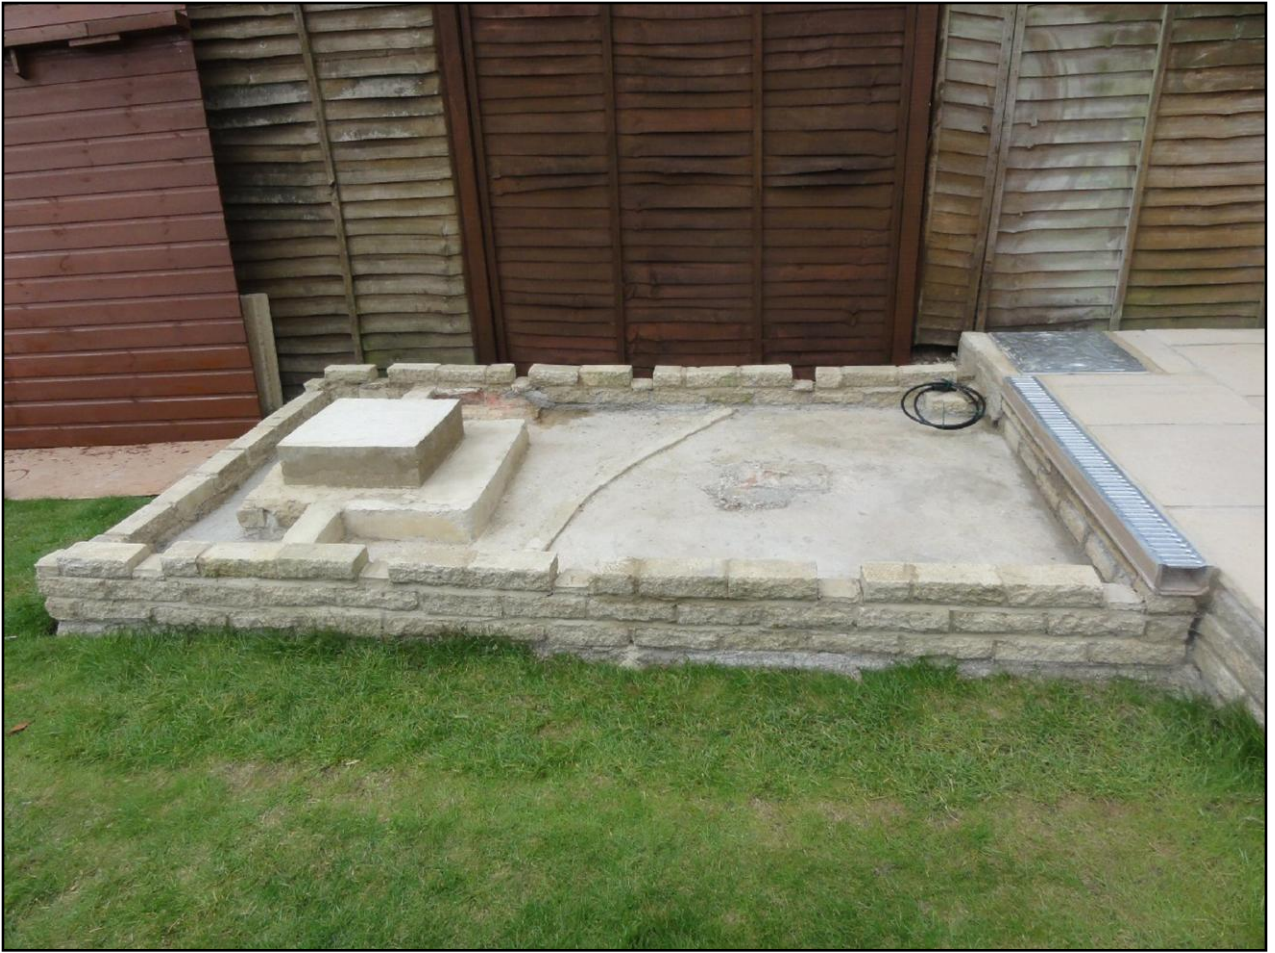
The pier foundation was cast and the shuttering removed. The space between the pier foundation and the new wall was filled with ballast and concrete. The mains electricity cable can be seen close to new the drain cover.

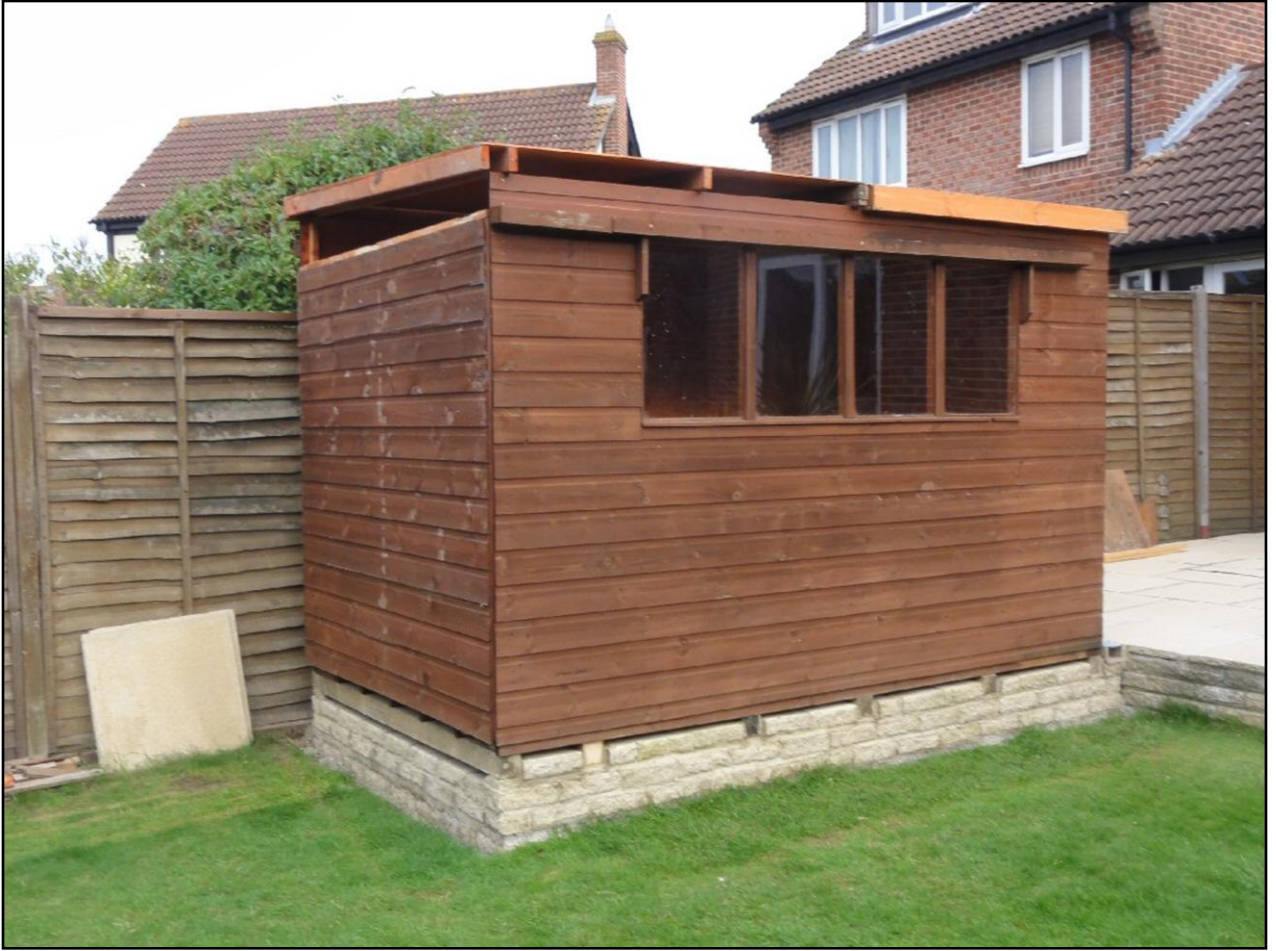
All the walls fitted. The two roof sections were put in place to establish the height of the sliding roof side support walls. The slope angle had to be carefully calculated so the sliding roof would not damage the fixed roof felt. When the original 'raised' roof was manufactured the second 'half' of the supplied roof was wrapped in heavy plastic sheet and stored between the observatory and the garden fence.

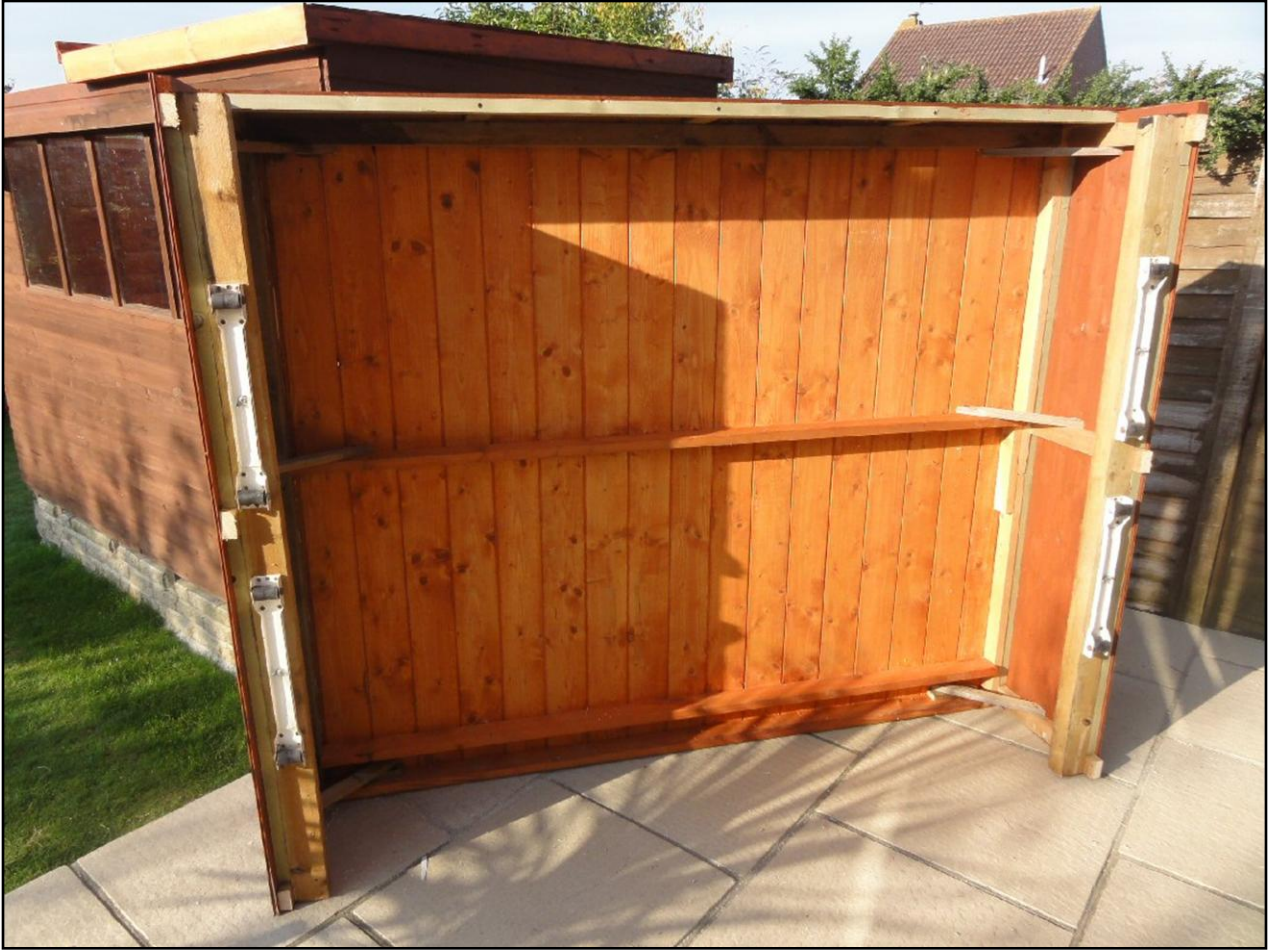
Assembling the new sliding roof with its side support walls and trolleys.

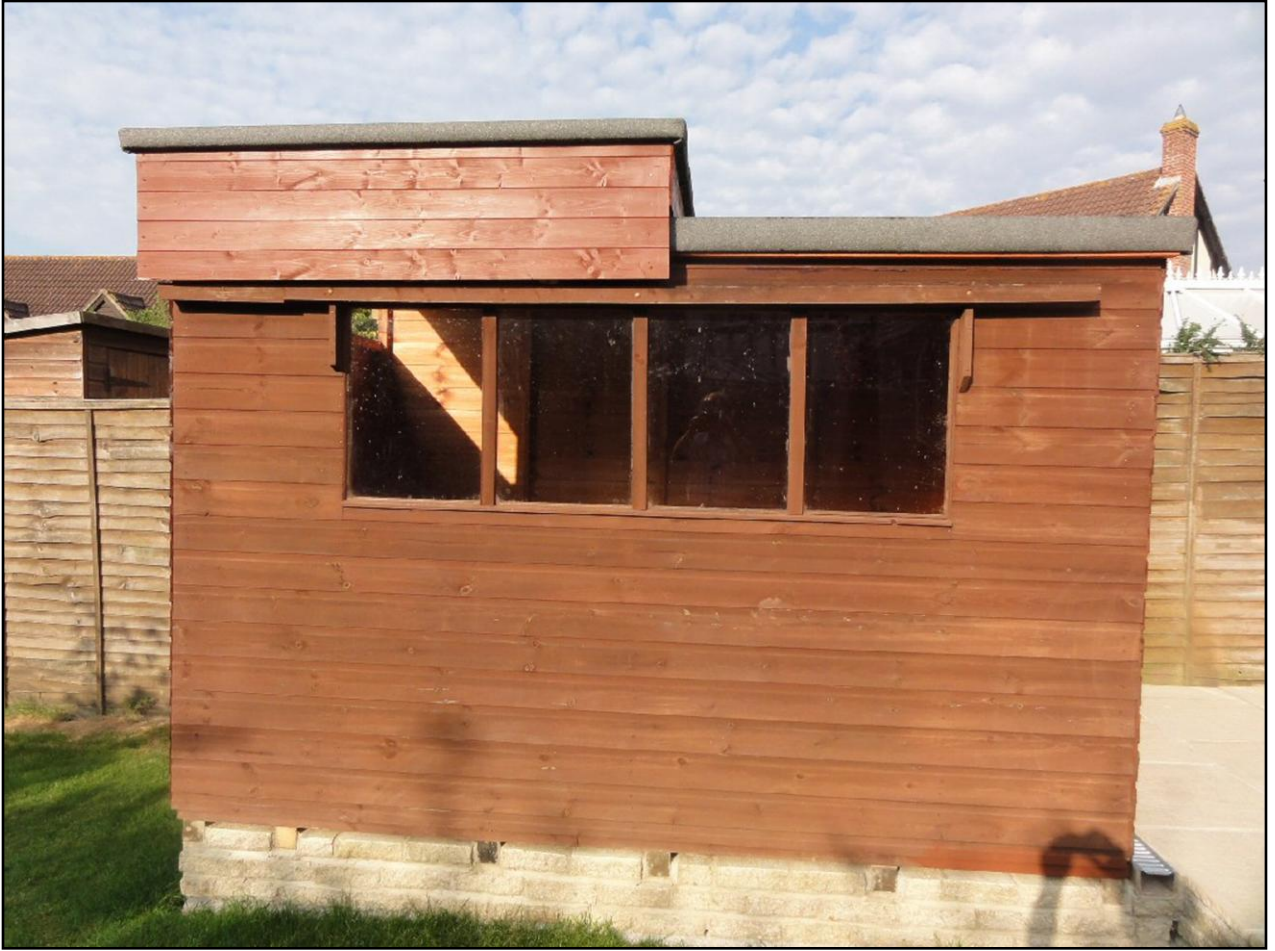
The sliding roof lifted on to the runners and slid forward to butt against the stop and sealing bar.

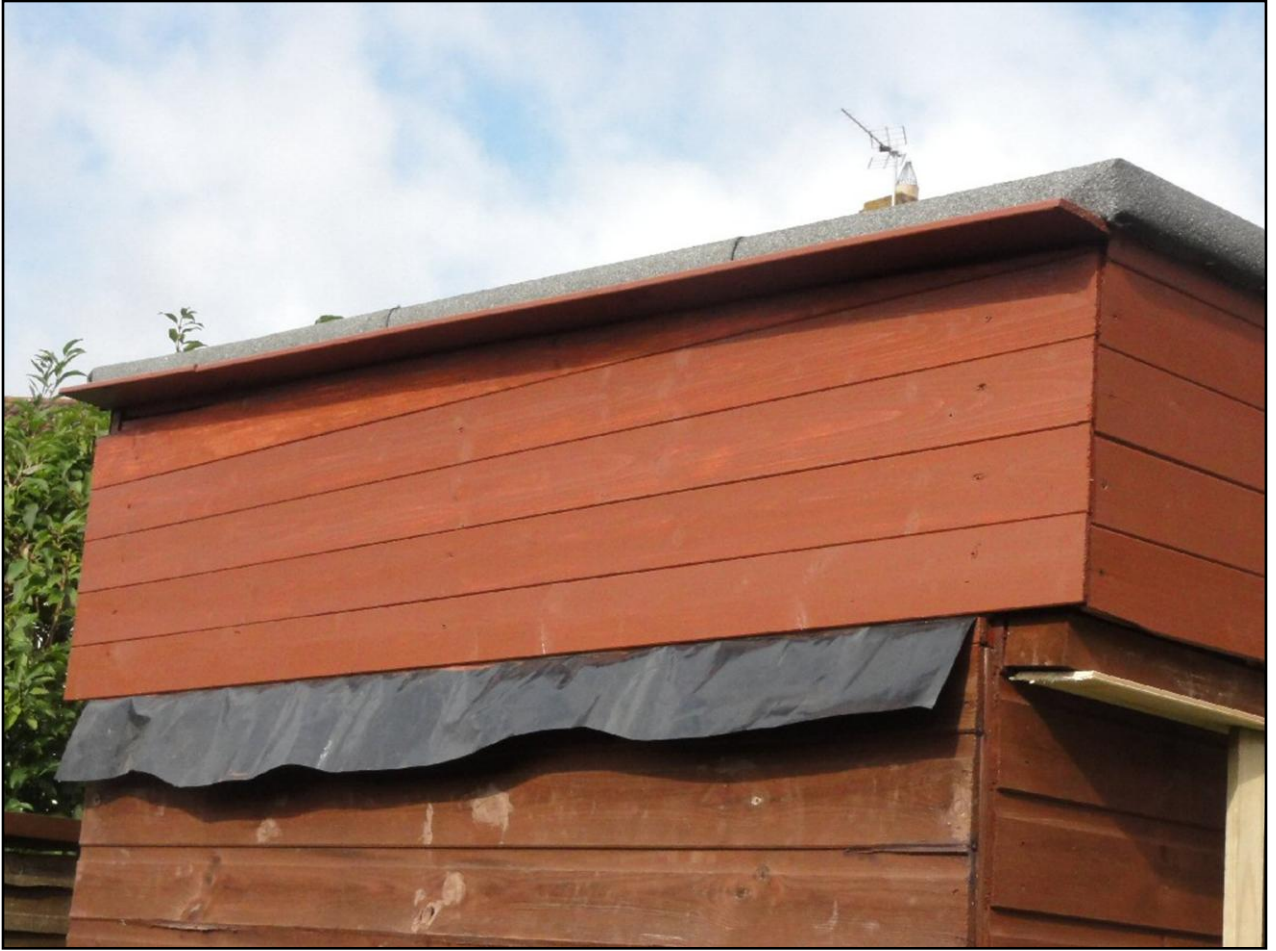
The low viewing / ventilation flap fitted into position with the rain seal sheet.

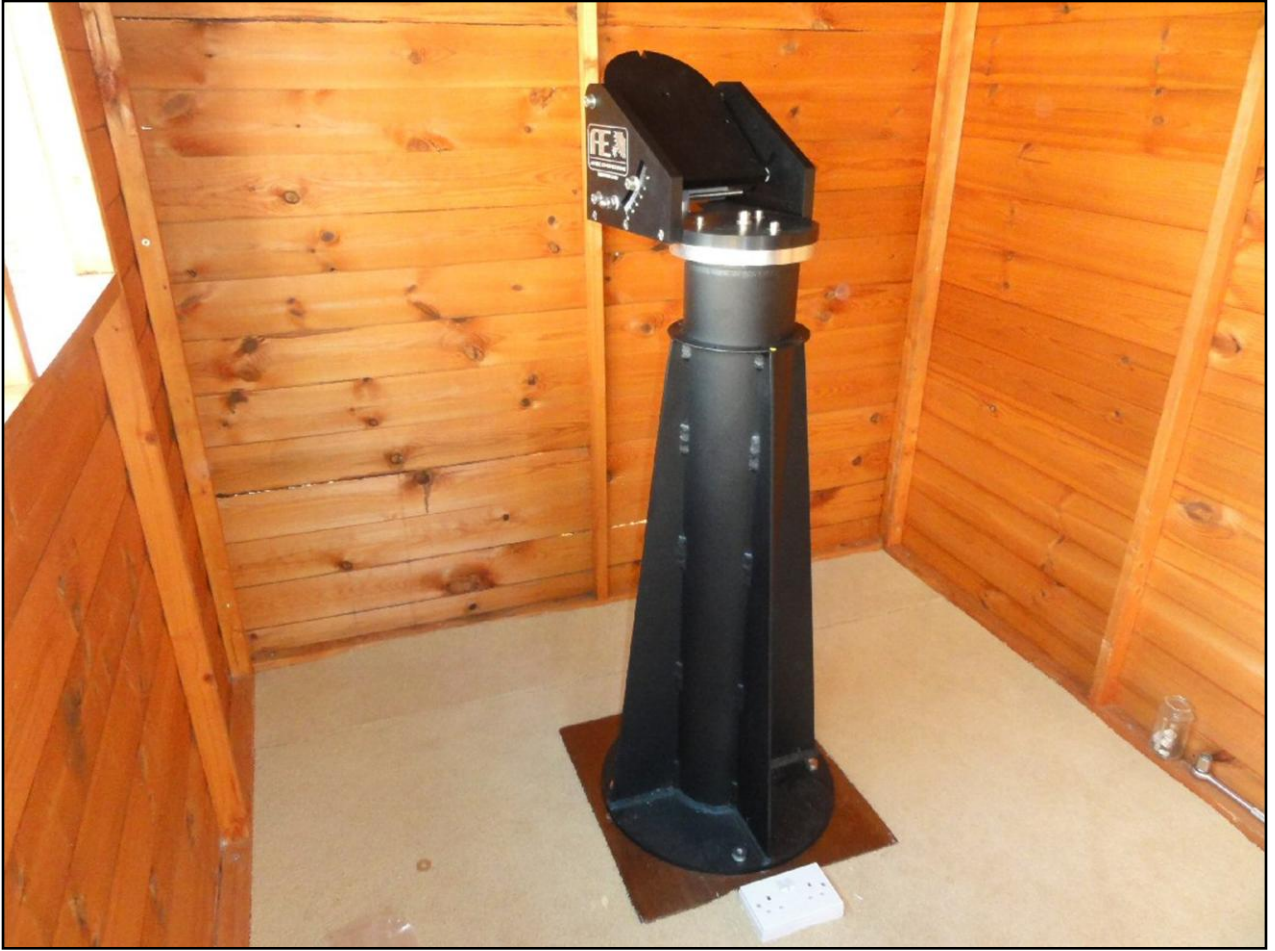
The Giant Equatorial Wedge fitted.

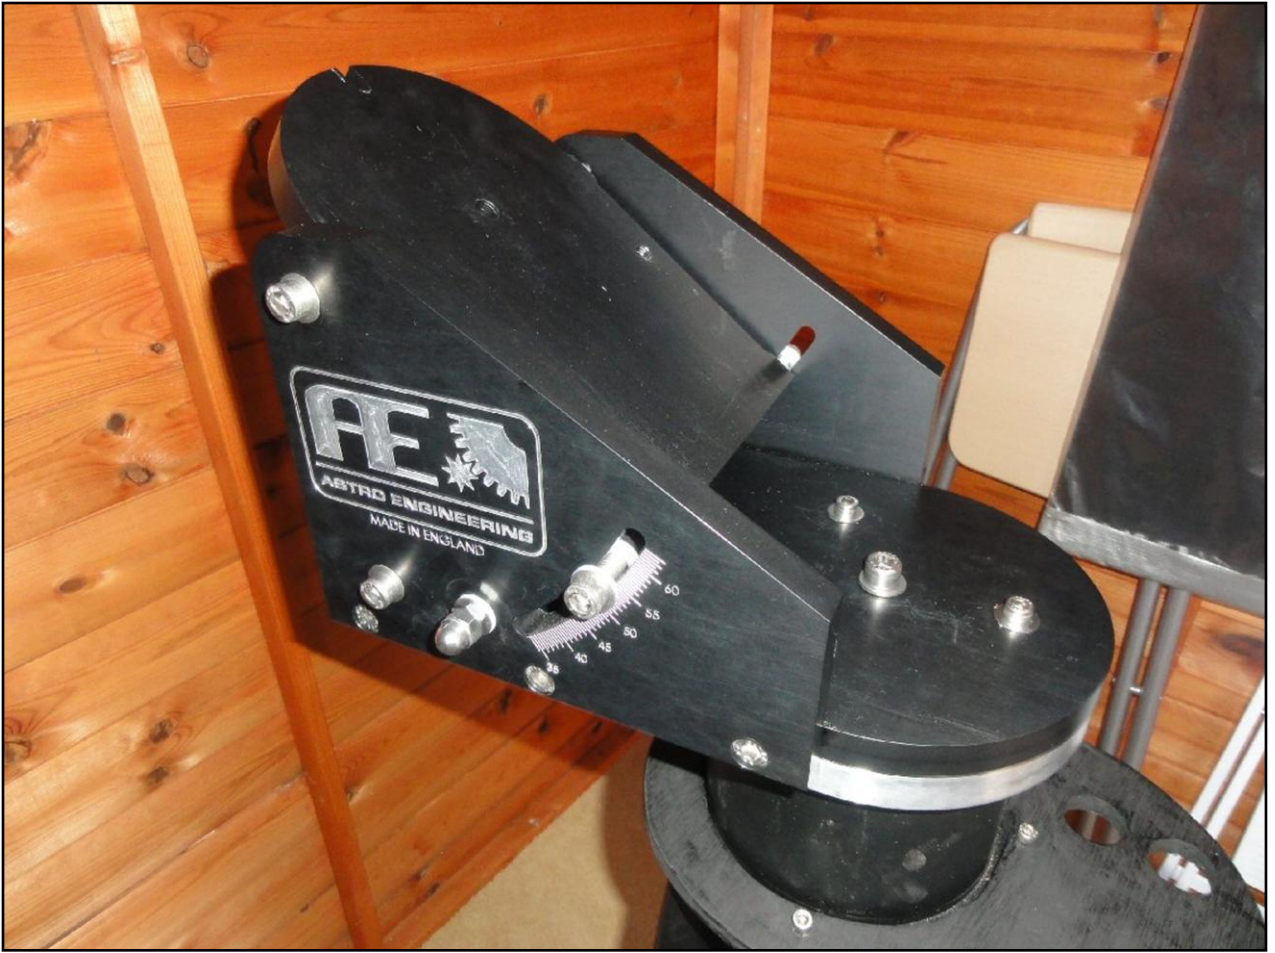
A close up view of the wedge latitude angle setting mechanism.
