Rebuilding My Observatory

Steve Harris

Rebuild of the Mk.2 Observatory

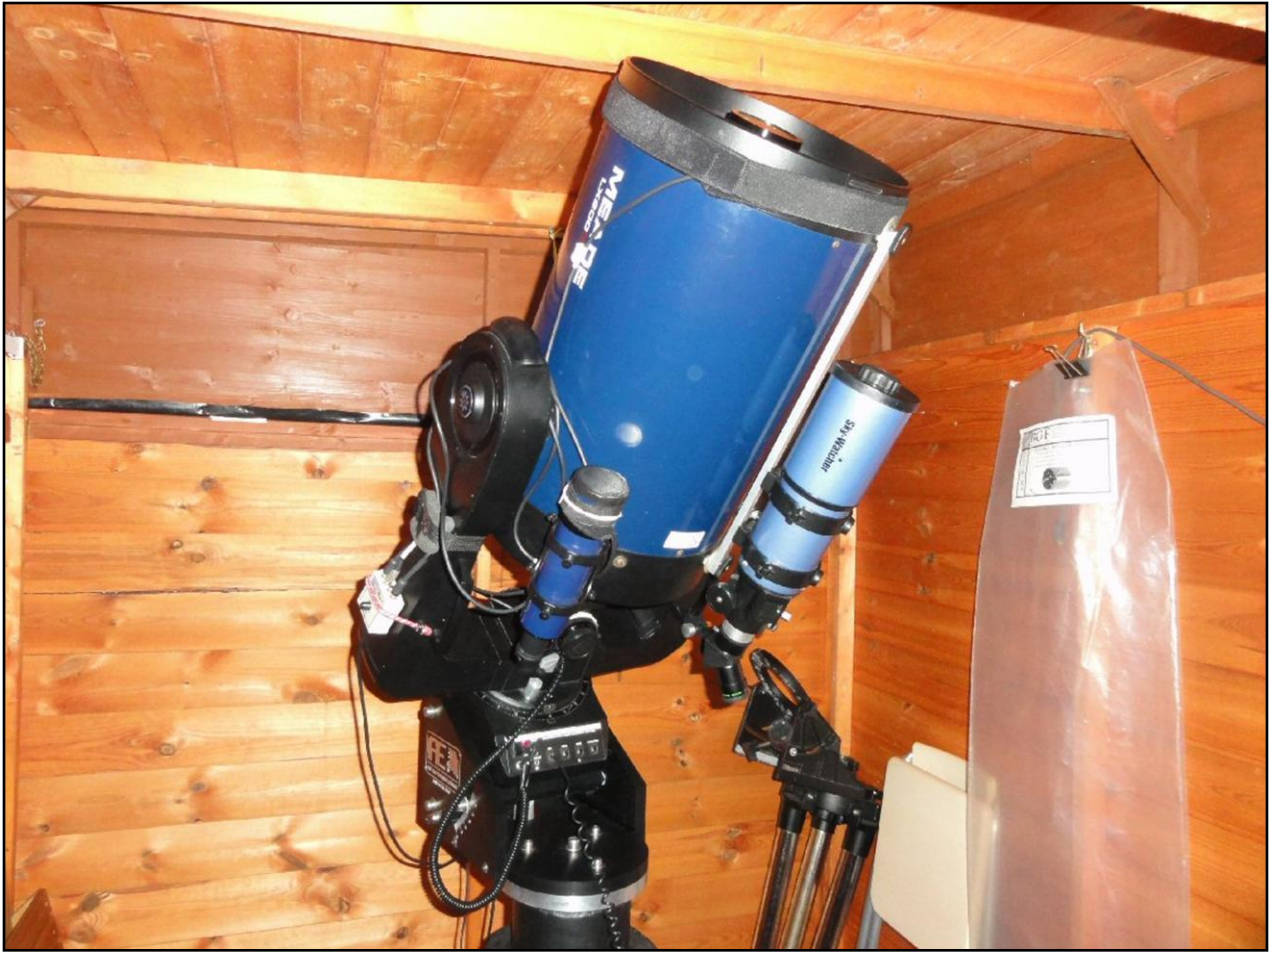
The telescope in the polar alignment position. Pointing to the Celestial Pole 90° Dec.

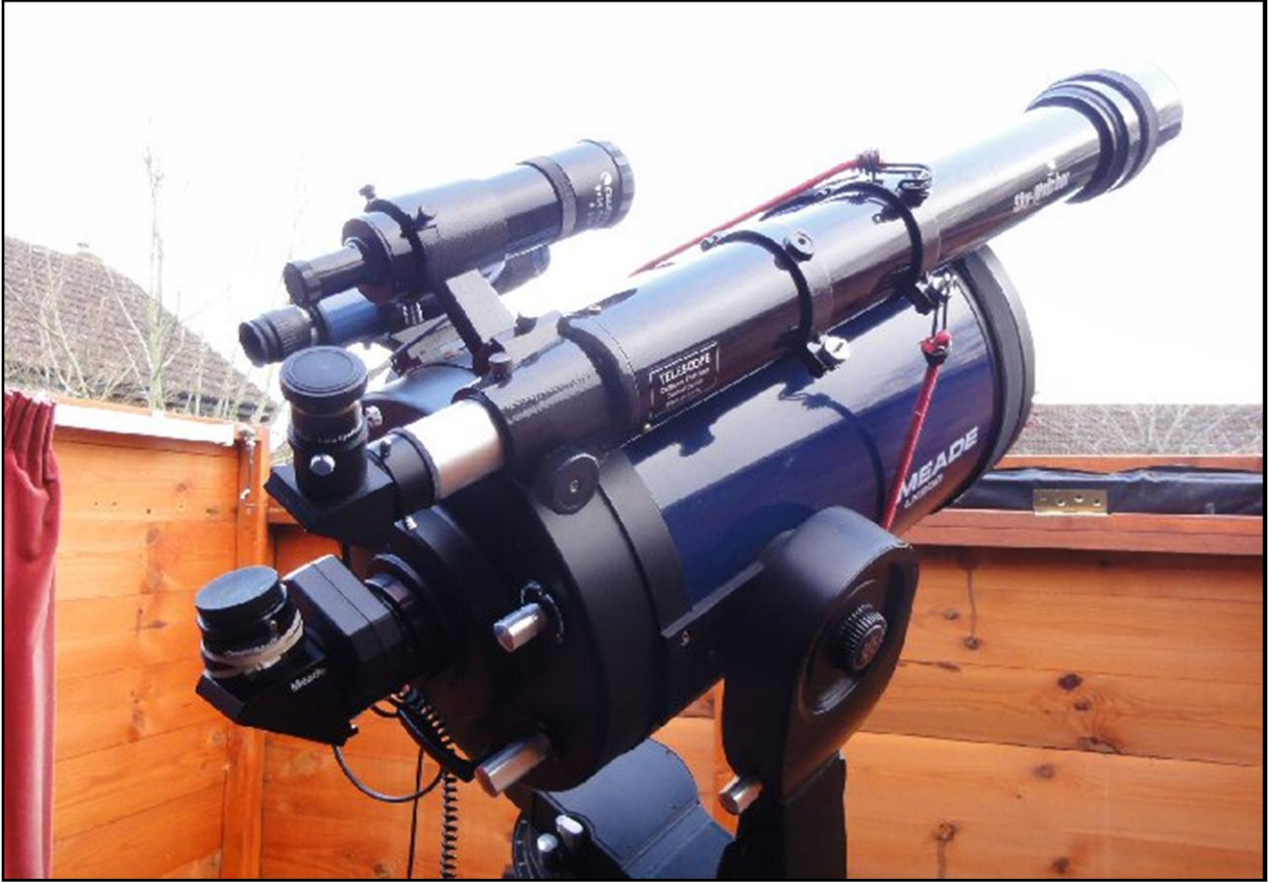
Peggy fitted with my 90mm Skywatcher 'piggy backed' for imaging the Jupiter / Saturn conjunction on 21st December 2020. Actually used on 20th December as the 21st was cloudy.
